Manhole Inspection Summary

Manhole # S09QQ1018MH

Insp Date: **4/18/07 2:20 PM**

Location Address: **3067 SPAULDING AVE**

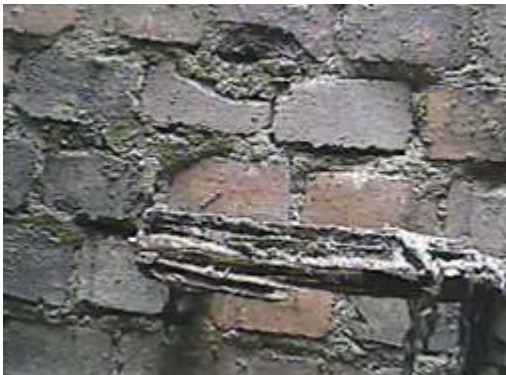
Defect 2

Count: **5** Missing: **0** ☒ **Corroded**

CORRODED RUNG

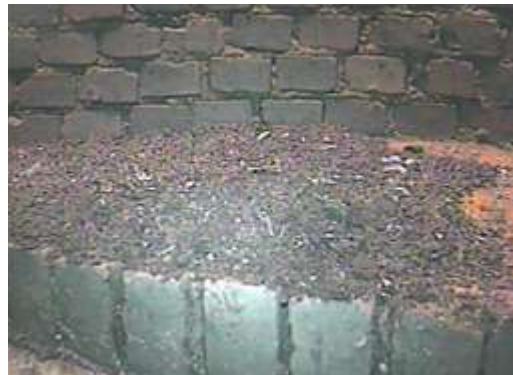
Defect 1

Condition: ☐ Sound ☐ Cracked ☐ Root Intrusion ☐ Deteriorated ☐ Leaks ☒ **Debris**

DEBRIS ON BENCH

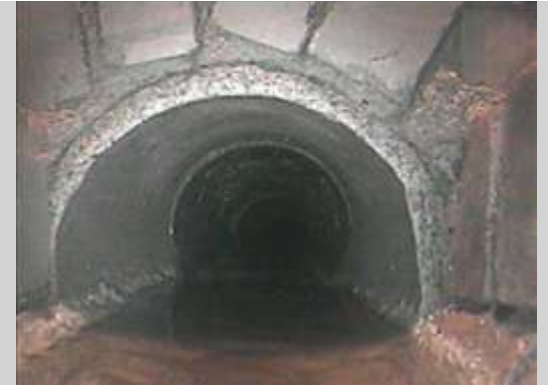
12 O'Clock Outflow

10 in. Circular Gravity Sewer
Pipe Out @ 12 O'Clock

Pipe Height: (in.) Direct
Pipe Material: **Clay** ☐ Pipe Lined
Invert Depth: **11.50** (ft.) Flow Characteristics: **Slow**
Deposits: ☒ None ☐ Mud ☐ Sludge ☐ **Debris** ☐ Grease
Silt Depth: (in.) Deposits Extent:
Infiltration: **None** Pipe Seal Cond: **Sound**

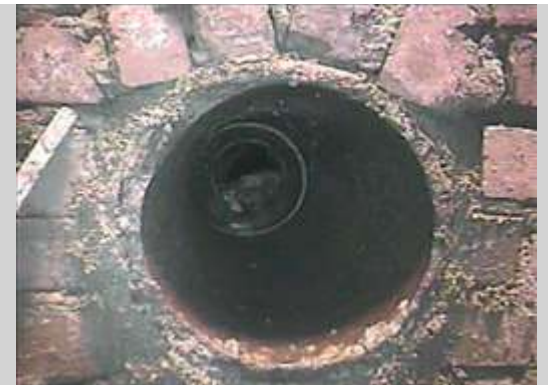
4 O'Clock Inflow

10 in. Circular Gravity Sewer
Pipe In @ 4 O'Clock

Pipe Height: (in.) Direct
Pipe Material: **Clay** ☐ Pipe Lined
Invert Depth: **8.50** (ft.) Flow Characteristics: **Slow**
Deposits: ☒ None ☐ Mud ☐ Sludge ☐ **Debris** ☐ Grease
Silt Depth: (in.) Deposits Extent:
Infiltration: **None** Pipe Seal Cond: **Sound**

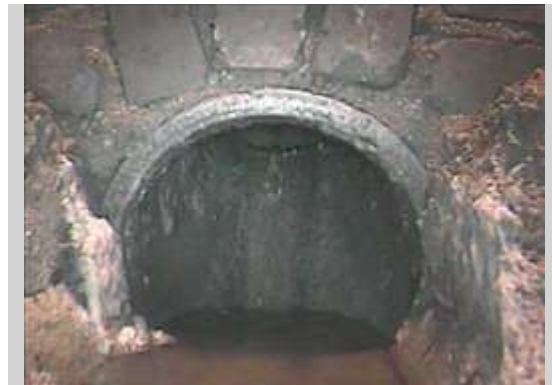
Drop In @ 4 O'Clock

Drop: **Outside Direct**
Angled: Reading: (ft.)
Inv Depth: **11.45** (ft.)
Drop Condition: **Open**

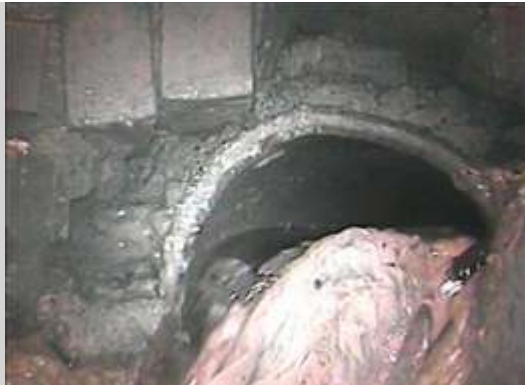
6 O'Clock Inflow

10 in. Circular Gravity Sewer
Pipe In @ 6 O'Clock

Deposits: ☐ None ☐ Mud ☐ Sludge ☒ **Debris** ☐ Grease

Silt Depth: **4** (in.) Deposits Extent: **Heavy**

Infiltration: **None** Pipe Seal Cond: **Broken**
